Manhole Inspection Summary

Manhole # S31GG2013MH

Location Address: **100 LAKE AVE**

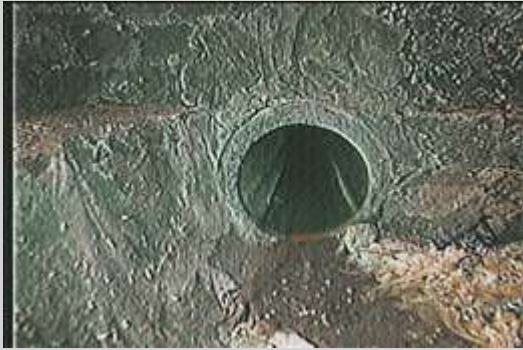
Pipe In @ 7 O'Clock

Deposits: ☐ None ☒ **Mud** ☐ Sludge ☐ **Debris** ☒ **Grease**

Infiltration: **None** Pipe Seal Cond: **Unknown**
